# **INDOOR AIR QUALITY ASSESSMENT**

**Framingham High School  
115 A Street  
Framingham, Massachusetts 01701**

Prepared by:  
Massachusetts Department of Public Health  
Center for Environmental Health  
Emergency Response/Indoor Air Quality Program  
December 2005

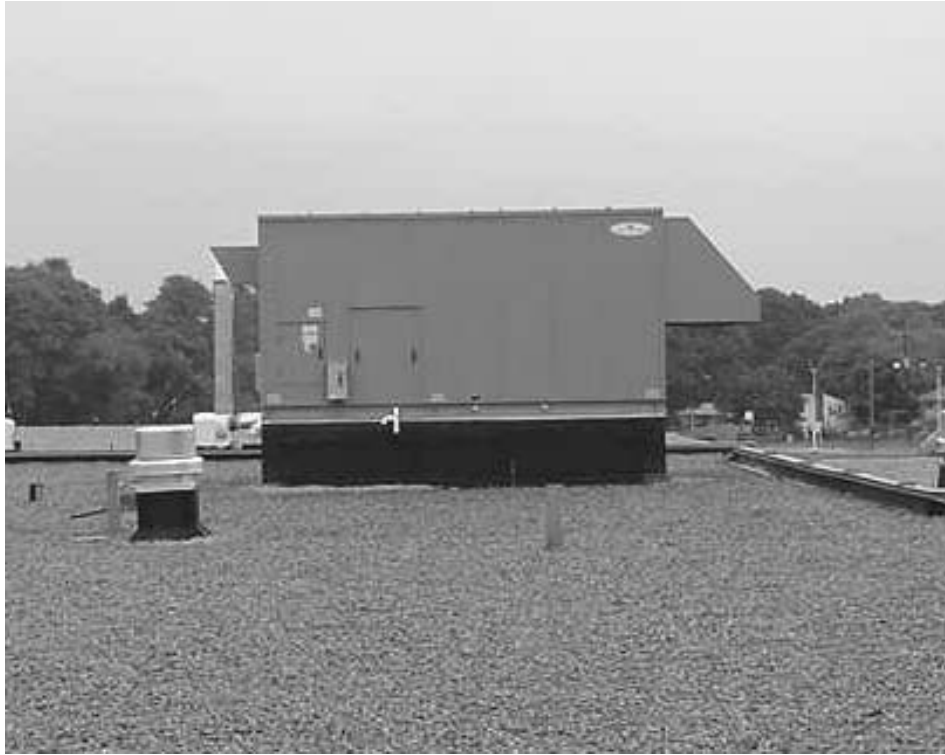
**Picture 1**

Mechanical ventilation is provided by rooftop air-handling units (AHUs) equipped with high efficiency pleated air filters (Pictures 1 and 2). Fresh air is continuously distributed via ceiling-mounted air diffusers (Picture 3) and ducted back to AHUs via ceiling or wall-mounted return vents (Picture 4). In some cases, the location of exhaust vents can limit exhaust efficiency. In several classrooms, exhaust vents are located above hallway doors (Picture 5). When classroom doors are open, exhaust vents will tend to draw air from both the hallway and the classroom, reducing the effectiveness of the exhaust vent to remove common environmental pollutants. In science classrooms, general exhaust ventilation is designed to be provided by the continuous operation of laboratory hoods. The supply vent in science classroom C-219 was located directly above the laboratory hood (Picture 6). In this configuration the laboratory hood

**Rooftop Air Handling Unit (AHU)**

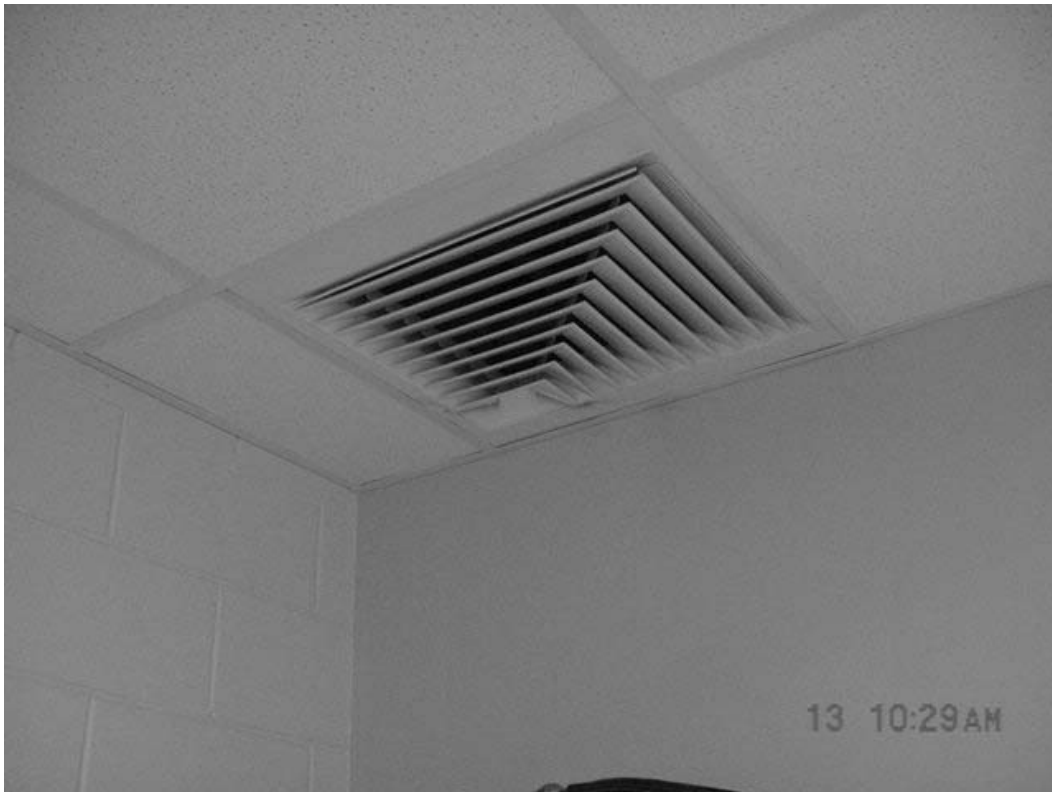
**Picture 3**

**Ceiling-Mounted Supply Vent**

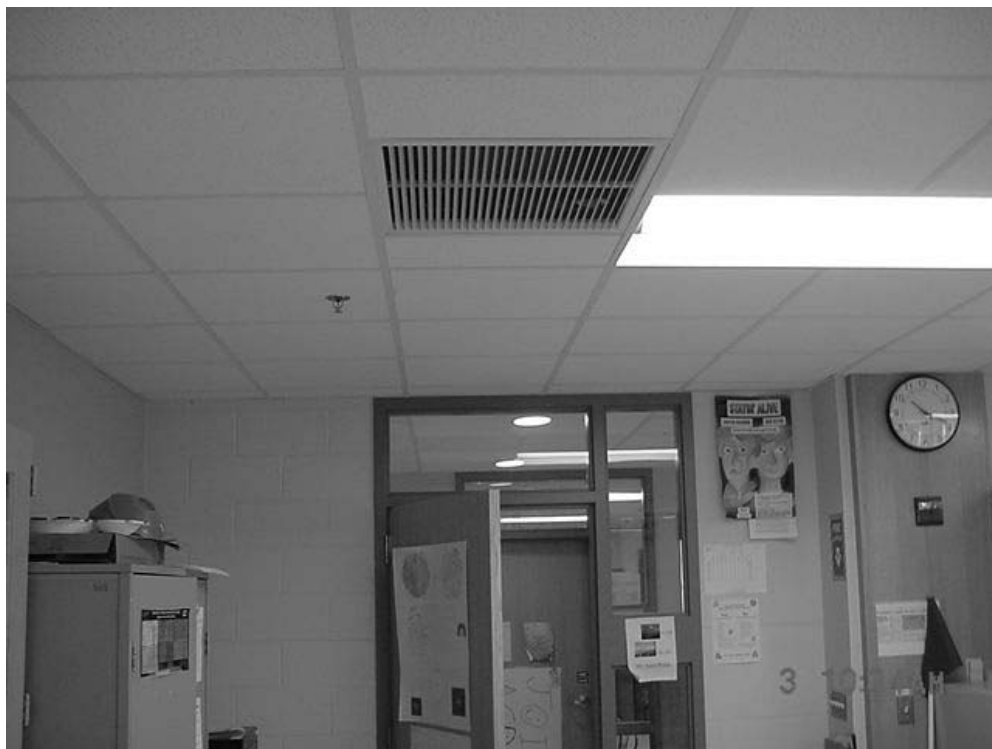
**Picture 4**

**Ceiling-Mounted Return Vent, Note Proximity to Open Classroom Door**

6. Close classroom doors to maximize air exchange.
7. For buildings in New England, periods of low relative humidity during the winter are often unavoidable. Therefore, scrupulous cleaning practices should be adopted to minimize common indoor air contaminants whose irritant effects can be enhanced when the relative humidity is low. To control for dusts, a high efficiency particulate arrestance (HEPA) filter equipped vacuum cleaner in conjunction with wet wiping of all surfaces is recommended. Avoid the use of feather dusters. Drinking water during the day can help ease some symptoms associated with a dry environment (throat and sinus irritations).

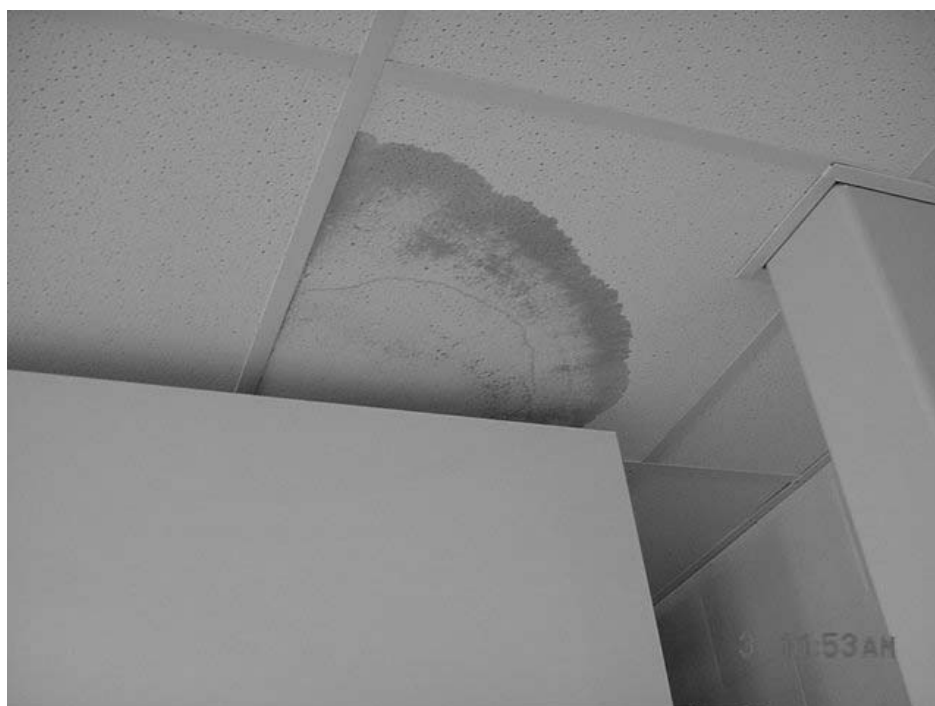
**Picture 6**

A few areas had water-damaged ceiling tiles (Picture 6), which can indicate leaks from either the roof or plumbing system. Water-damaged ceiling tiles can provide a source of mold and should be replaced after a water leak is discovered and repaired.

**Water Damaged Ceiling Tile**

8. Ensure roof/plumbing leaks are repaired and replace water damaged ceiling tiles. Examine the area above and around these areas for mold growth. Disinfect areas of water leaks with an appropriate antimicrobial.

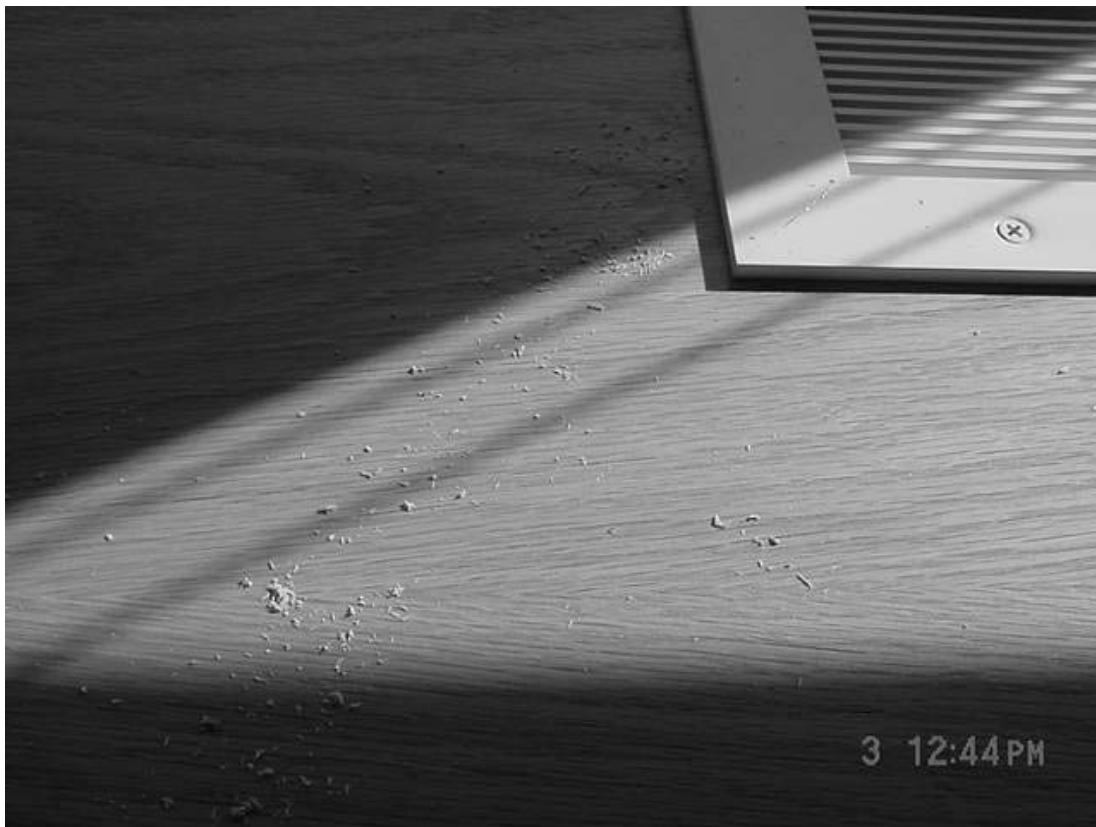
**Picture 7**

Accumulation of wood dust was observed in the library shelves near the windows (Picture 7).

Dust can be irritating to eyes, nose and respiratory tract.

**Wood Dust on Library Bookshelves Near Windows**

11. Relocate or consider reducing the amount of materials stored in classrooms to allow for more thorough cleaning of classrooms. Clean items regularly with a wet cloth or sponge to prevent excessive dust build-up.

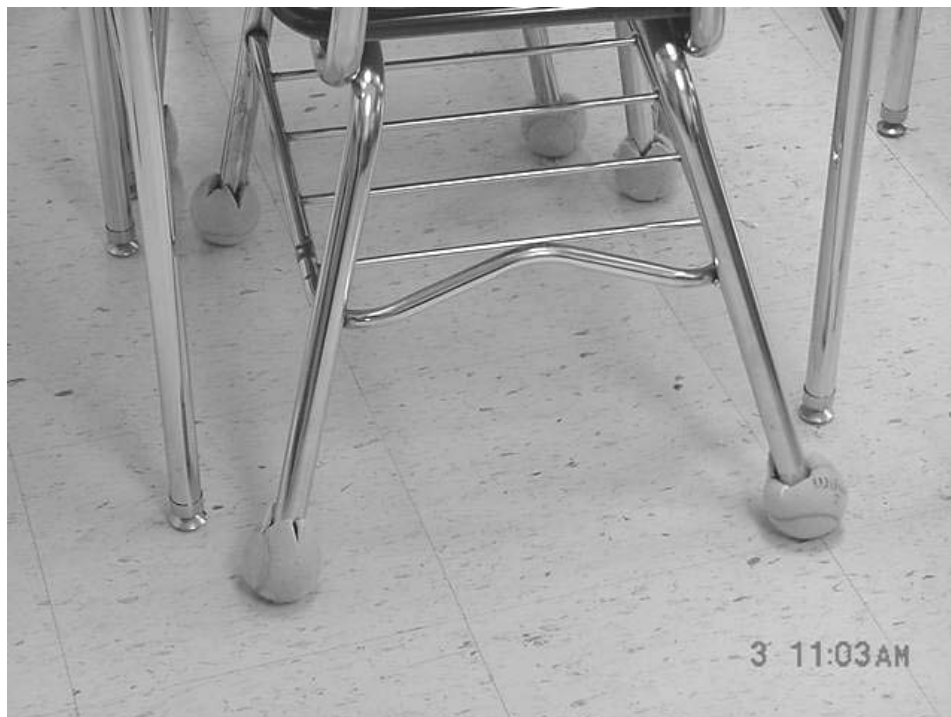
**Picture 8**

In an effort to reduce noise from sliding chairs, tennis balls had been sliced open and placed on chair legs (Picture 8). Tennis balls are made of a number of materials that are a source of respiratory irritants. Constant wearing of tennis balls can produce fibers and off-gas TVOCs. Tennis balls are made with a natural rubber latex bladder, which becomes abraded when used as a chair leg pad. Use of tennis balls in this manner may introduce latex dust into the school environment. Some individuals are highly allergic to latex (e.g., spina bifida patients) (SBAA, 2001). It is recommended that the use of materials containing latex be limited in buildings to reduce the likelihood of symptoms in sensitive individuals (NIOSH, 1997). A question and answer sheet concerning latex allergy is attached as [Appendix B](#) (NIOSH, 1998).

**Tennis Balls on Chair Legs**

12. Consider discontinuing the use of tennis balls on chairs to prevent latex dust generation. Consider replacing with alternative “glides” (Picture 9).
